BRAZORIA COUNTY HISTORICAL MUSEUM
EXTERIOR RESTORATION AND REPAIR
ANGLETON, TEXAS

SHEET NAME:
DETAILS

A-400

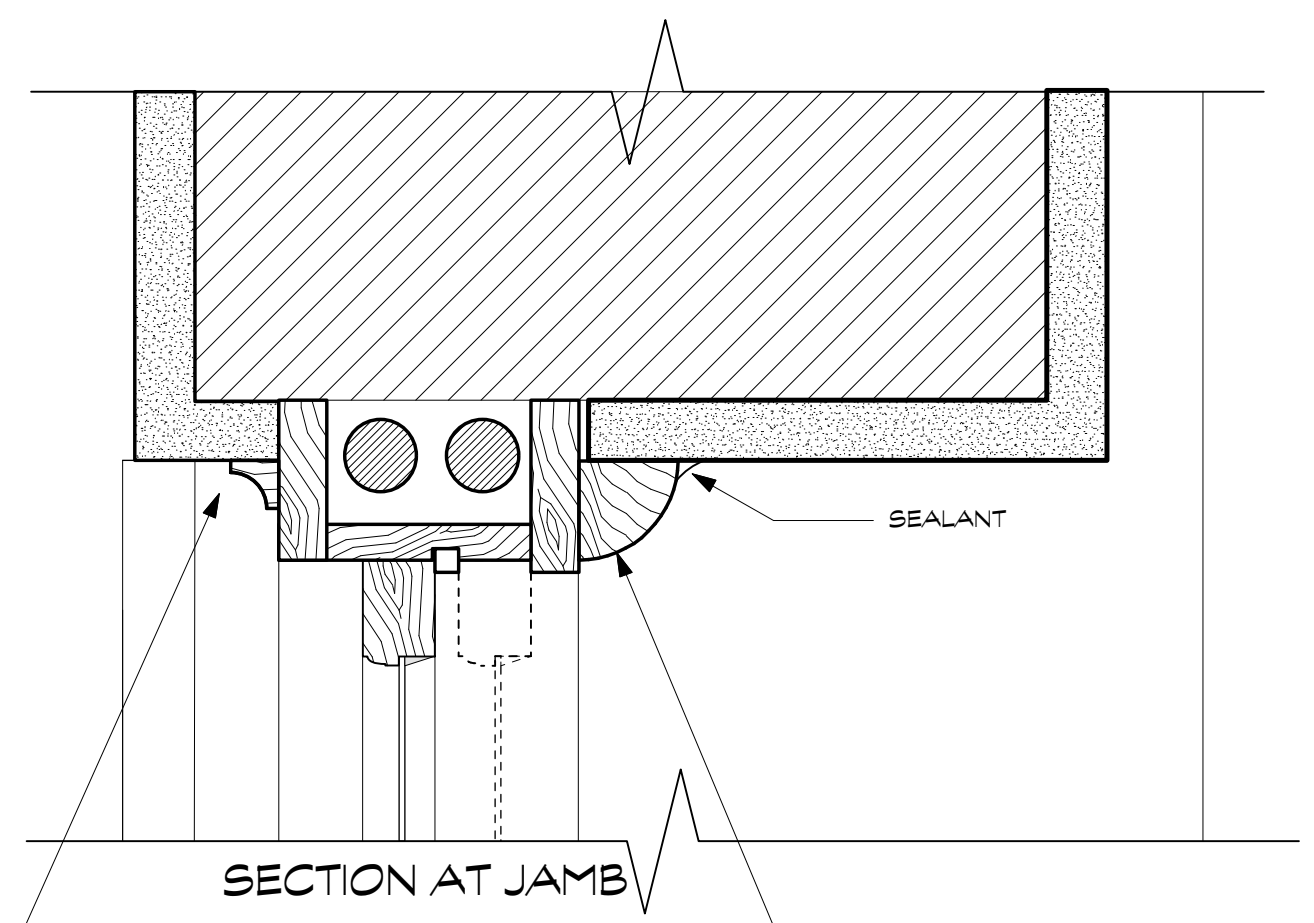
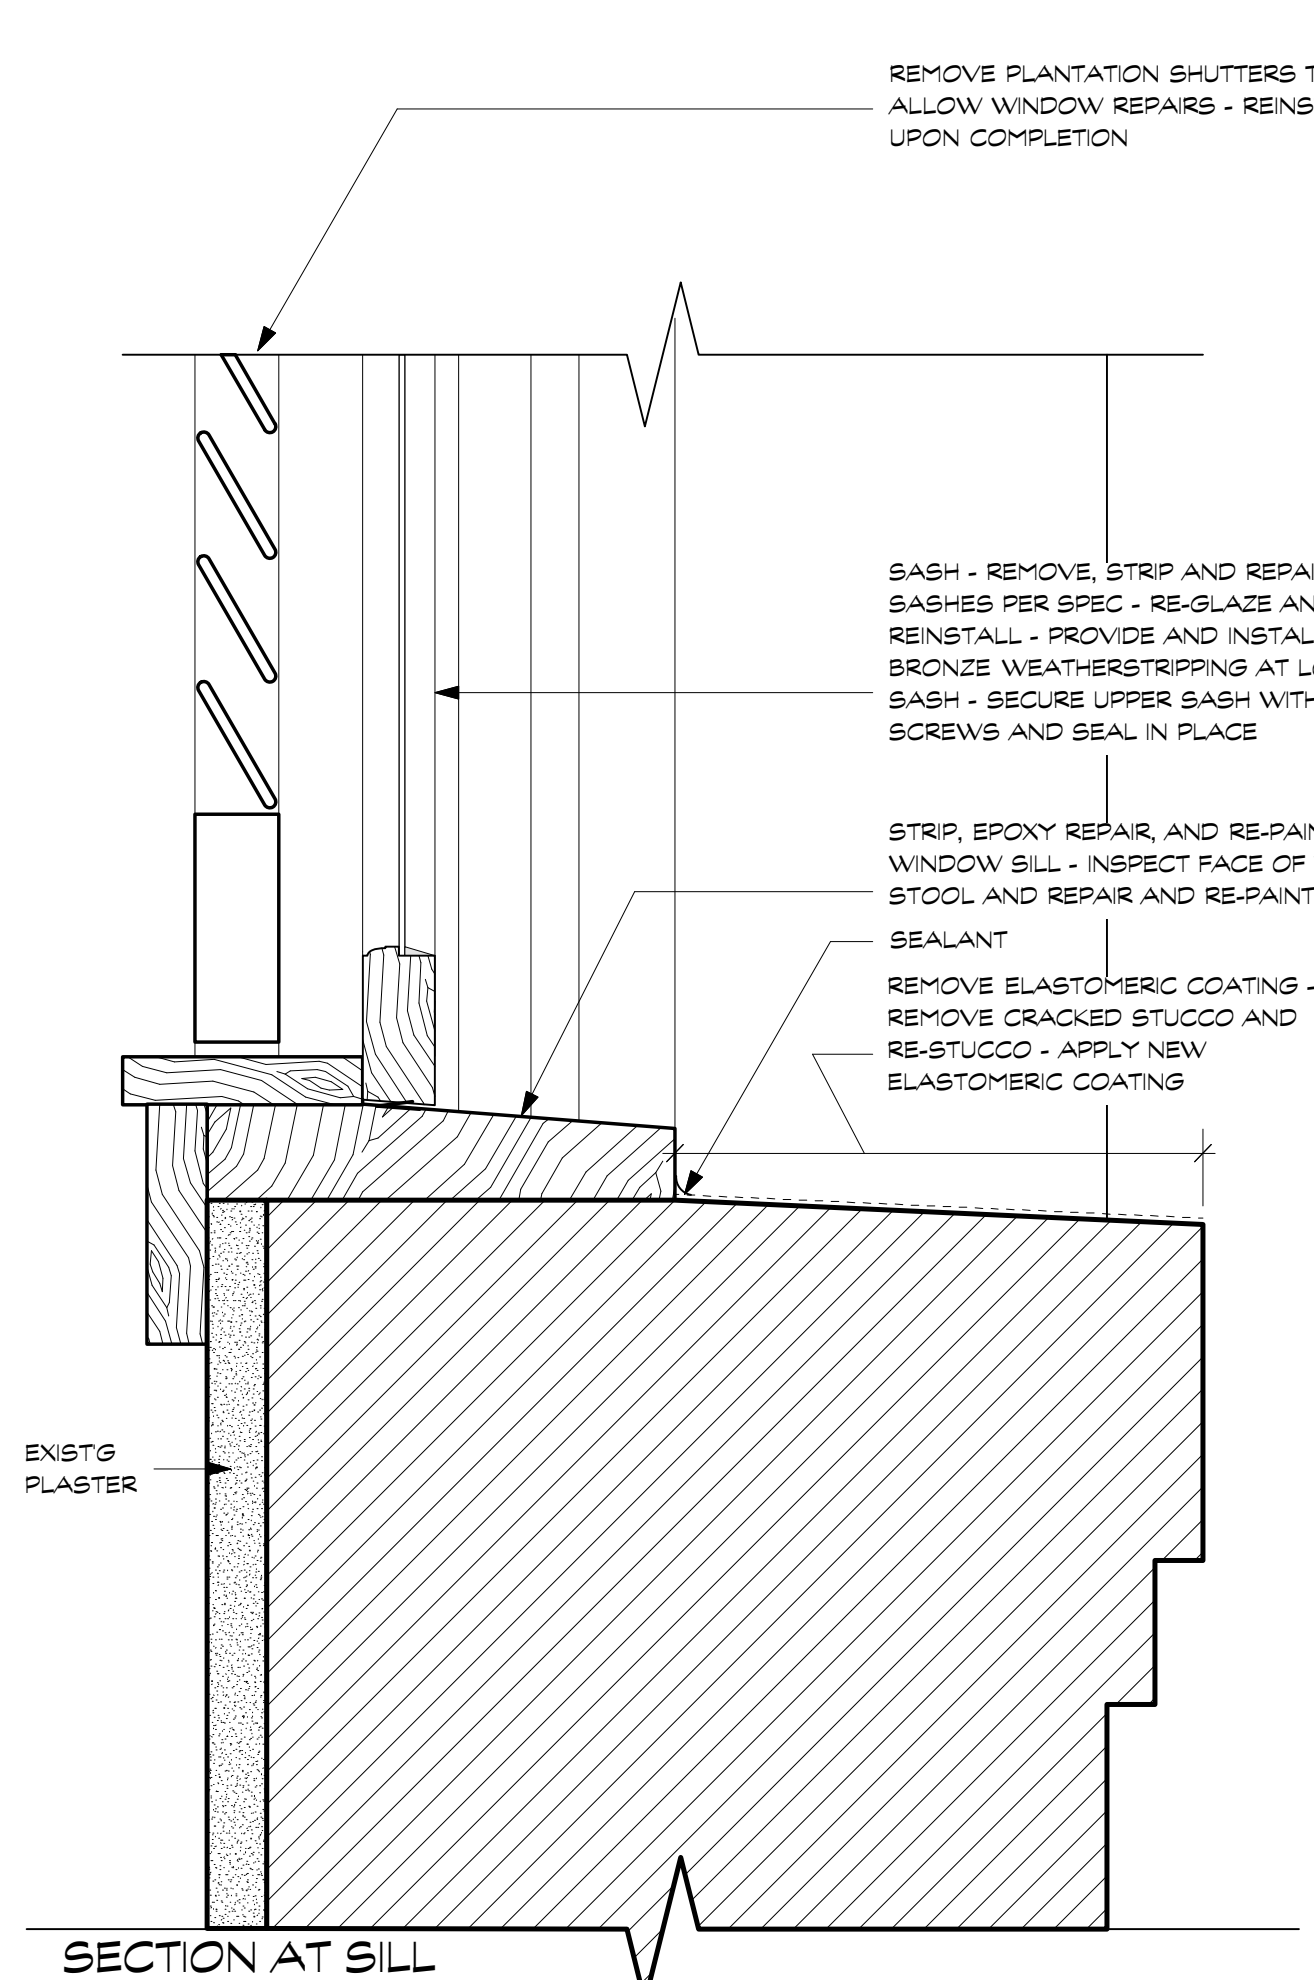
A1 WINDOW DETAIL
SCALE: 3" = 1'-0"

INSPECT JAMB, TRIM AND BRICK MOLD AFTER SASH REMOVAL AND EPOXY REPAIR AS NEEDED - REPLACE SEVERELY DAMAGED PIECES WITH NEW TRTD WOOD - RE-SECURE LOOSE TRIM - SAND PRIME AND RE-PAINT ALL EXT. WOOD - REMOVE ALL EXISTING SEALANT RESIDUE AND RE-SEAL PERIMETER
